DEFENSE ATOMIC SUPPORT AGENCY WASHINGTON DC
BIKINI SCIENTIFIC RESURVEY. VOLUME III. REPORT OF THE DIRECTOR --ETC(U)
DEC 47

REPORT OF THE DIRECTOR
OF SHIP MATERIAL

TECHNICAL REPORT BIKINI SCIENTIFIC RESURVEY

Edited and Published by
Navy Forces Special Weapons Project
December 1947

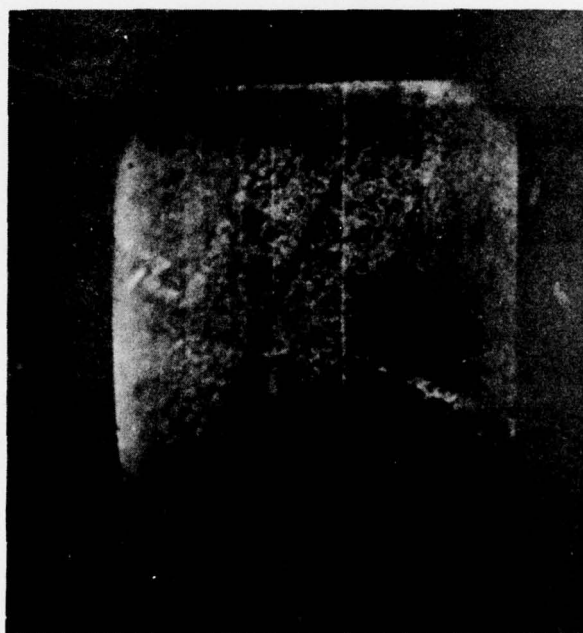
Figure 24. TELEVISION. Starboard catapult and securing track in flight deck of SARATOGA. ABCR Photo No. 5109-11.

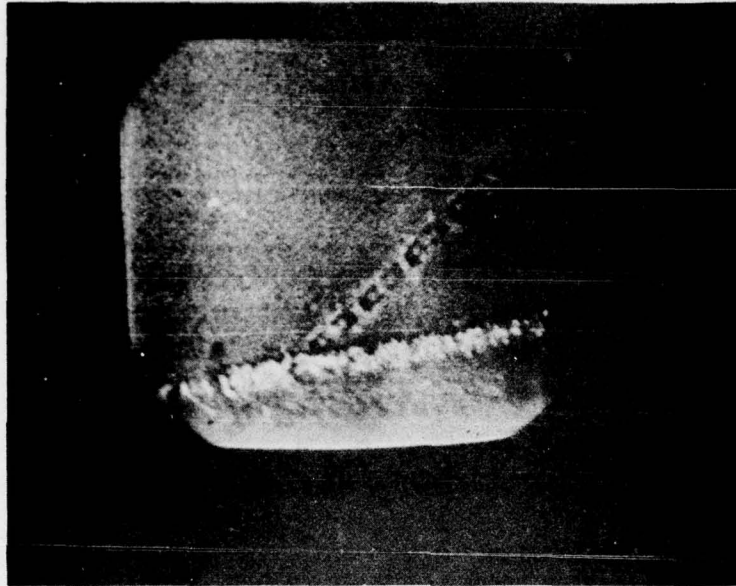
Figure 26. TELEVISION. Securing track on flight deck of SARATOGA showing radio antenna bent across deck to port. ABCR Photo No. 5106-12.
